Some Answers to the November 2012 Beacon "Find the Problem" Contest

January 2013

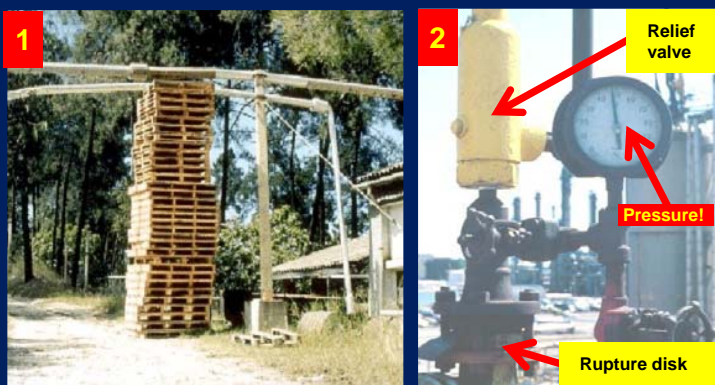
1. This is an easy one! Piping support is extremely poor!
2. The pressure between the rupture disk and the relief valve compromises the integrity of the emergency pressure relief system. Rupture disks burst when the difference between the upstream pressure and the downstream pressure exceeds the rupture pressure. If there is pressure downstream of the disk, it will not burst at the intended process pressure.

3. Despite the warning sign, the plug in the bonnet of this bellows sealed safety valve (which protects the valve during shipping) has not been removed. This will affect the pressure at which the valve opens.

4. Flexible hoses are being used to connect piping which does not fit together properly. Also, the flange on the right appears to be missing at least one bolt and the faces of the flange do not align properly.

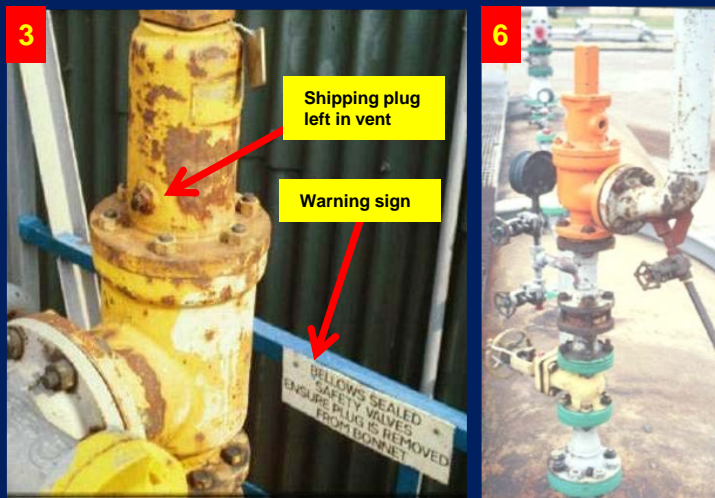
5. All of these pumps are identical in appearance and there is no evidence of any labeling.
6. The valves and other pipe fittings on the inlet of the relief valve (RV) result in greater inlet pressure drop, which could cause relief valve chattering. The block valve on the RV inlet does not appear to have anything to prevent closing it and isolating the RV from the process.

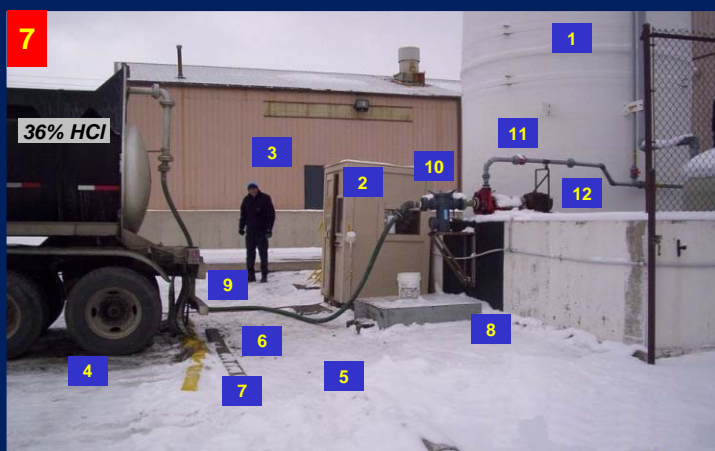
7. There are many hazards in this photograph. Here are some of them, (you may find others!): (1) no visible label on the storage tank; (2) no eye wash or safety shower in the area; (3) the person in the picture is not wearing any personal protective equipment; (4) no chocks at tank truck wheels; (5) no visible spill containment; (6) many tripping hazards (and slipping hazards from the snow); (7) little or nothing to prevent backing the truck into the shed and unloading piping; (8) inadequate platform to access the unloading connection; (9) no way to drain the hose when unloading is complete; (10) no pressure gages anywhere on the unloading piping; (11) the valve handle downstream of the pump is too high; (12) the unloading piping is poorly supported.
